Appropriate Countermeasures for Hazardous Site: Glenwood Ave and Peace St., Raleigh, North Carolina

Mike Roselli, EI

April 12, 2011

Published for CE 509 Highway Safety, Spring 2011 - Dr. Joseph Hummer, Dept. of Civil Engineering, North Carolina State University, Campus Box 7908, Raleigh, North Carolina 27695-7908. Corresponding author: Mike Roselli, marosell@ncsu.edu

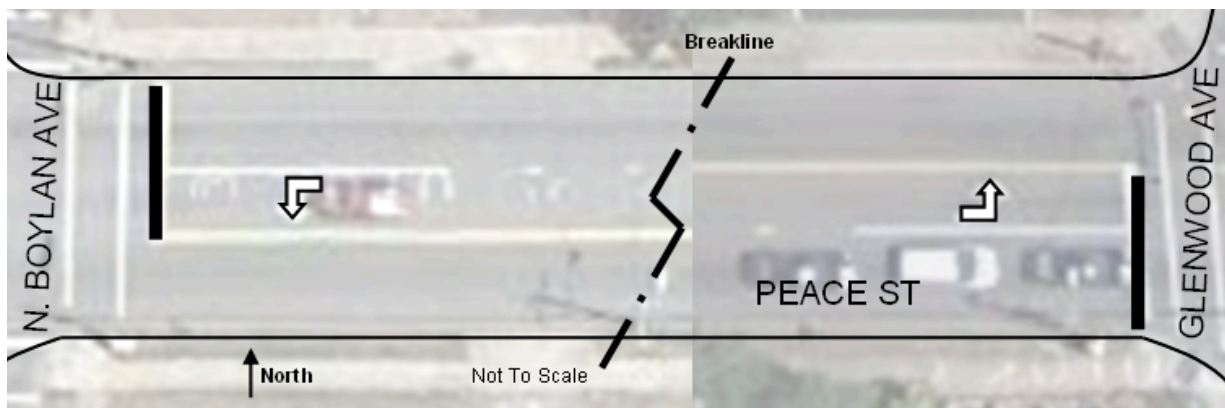
Figure 1: Existing Conditions

The driveways on eastbound Peace St. that provide access to Starbucks and Mellow Mushroom contributed to a large number of reported collisions and a large number of conflicts seen during the conflict study. These collisions mostly involve left-turning vehicles and right turning vehicles entering the eastbound left turn lane.

In the *Highway Safety Engineering Studies Procedural Guide* (1991), Parker recommends a median device installation to thwart collisions caused by left-turning vehicles. Upon observation of this site, I recommend this countermeasure for installation which can be seen in Figure 2. This will effectively provide a right-in-right-out solution, possibly to the chagrin of the Starbucks and Mellow Mushroom business owners and customers, but ultimately in the interests of driver safety.

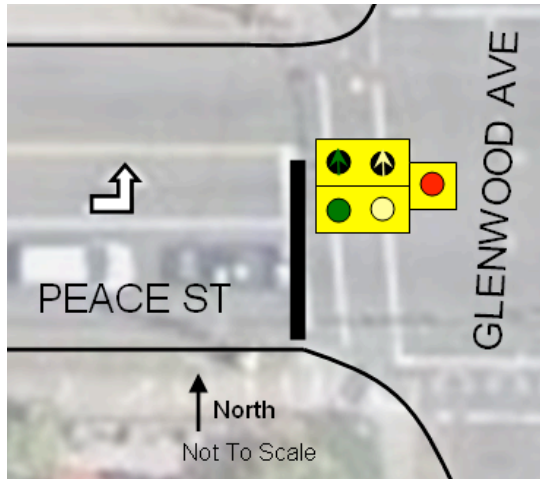
**Figure 3: Existing Conditions:
Protected/Permitted Left-turn Phasing**

These observations revealed high risk left turns onto Glenwood Ave from eastbound Peace St. There is inadequate sight distance of westbound movements caused by a steep, 16.6% grade due to a rail overpass further east. Also, long queues that build up on westbound Peace St encourage vehicles to try to increase their speed at yellow lights. However, the steep grade prevents vehicles from reaching the speed required resulting in westbound red-light runs.

A study titled *Accident Modification Factors for Traffic Engineering and ITS Improvements* by Harkey et. al. (2008) found that by changing the traffic control of left turns at urban intersections from protected-permitted to solely protected turns could reduce collisions by 99%, a crash modification of factor of .01. This study was rated five stars by the CMF Clearinghouse as highest and most reliable.

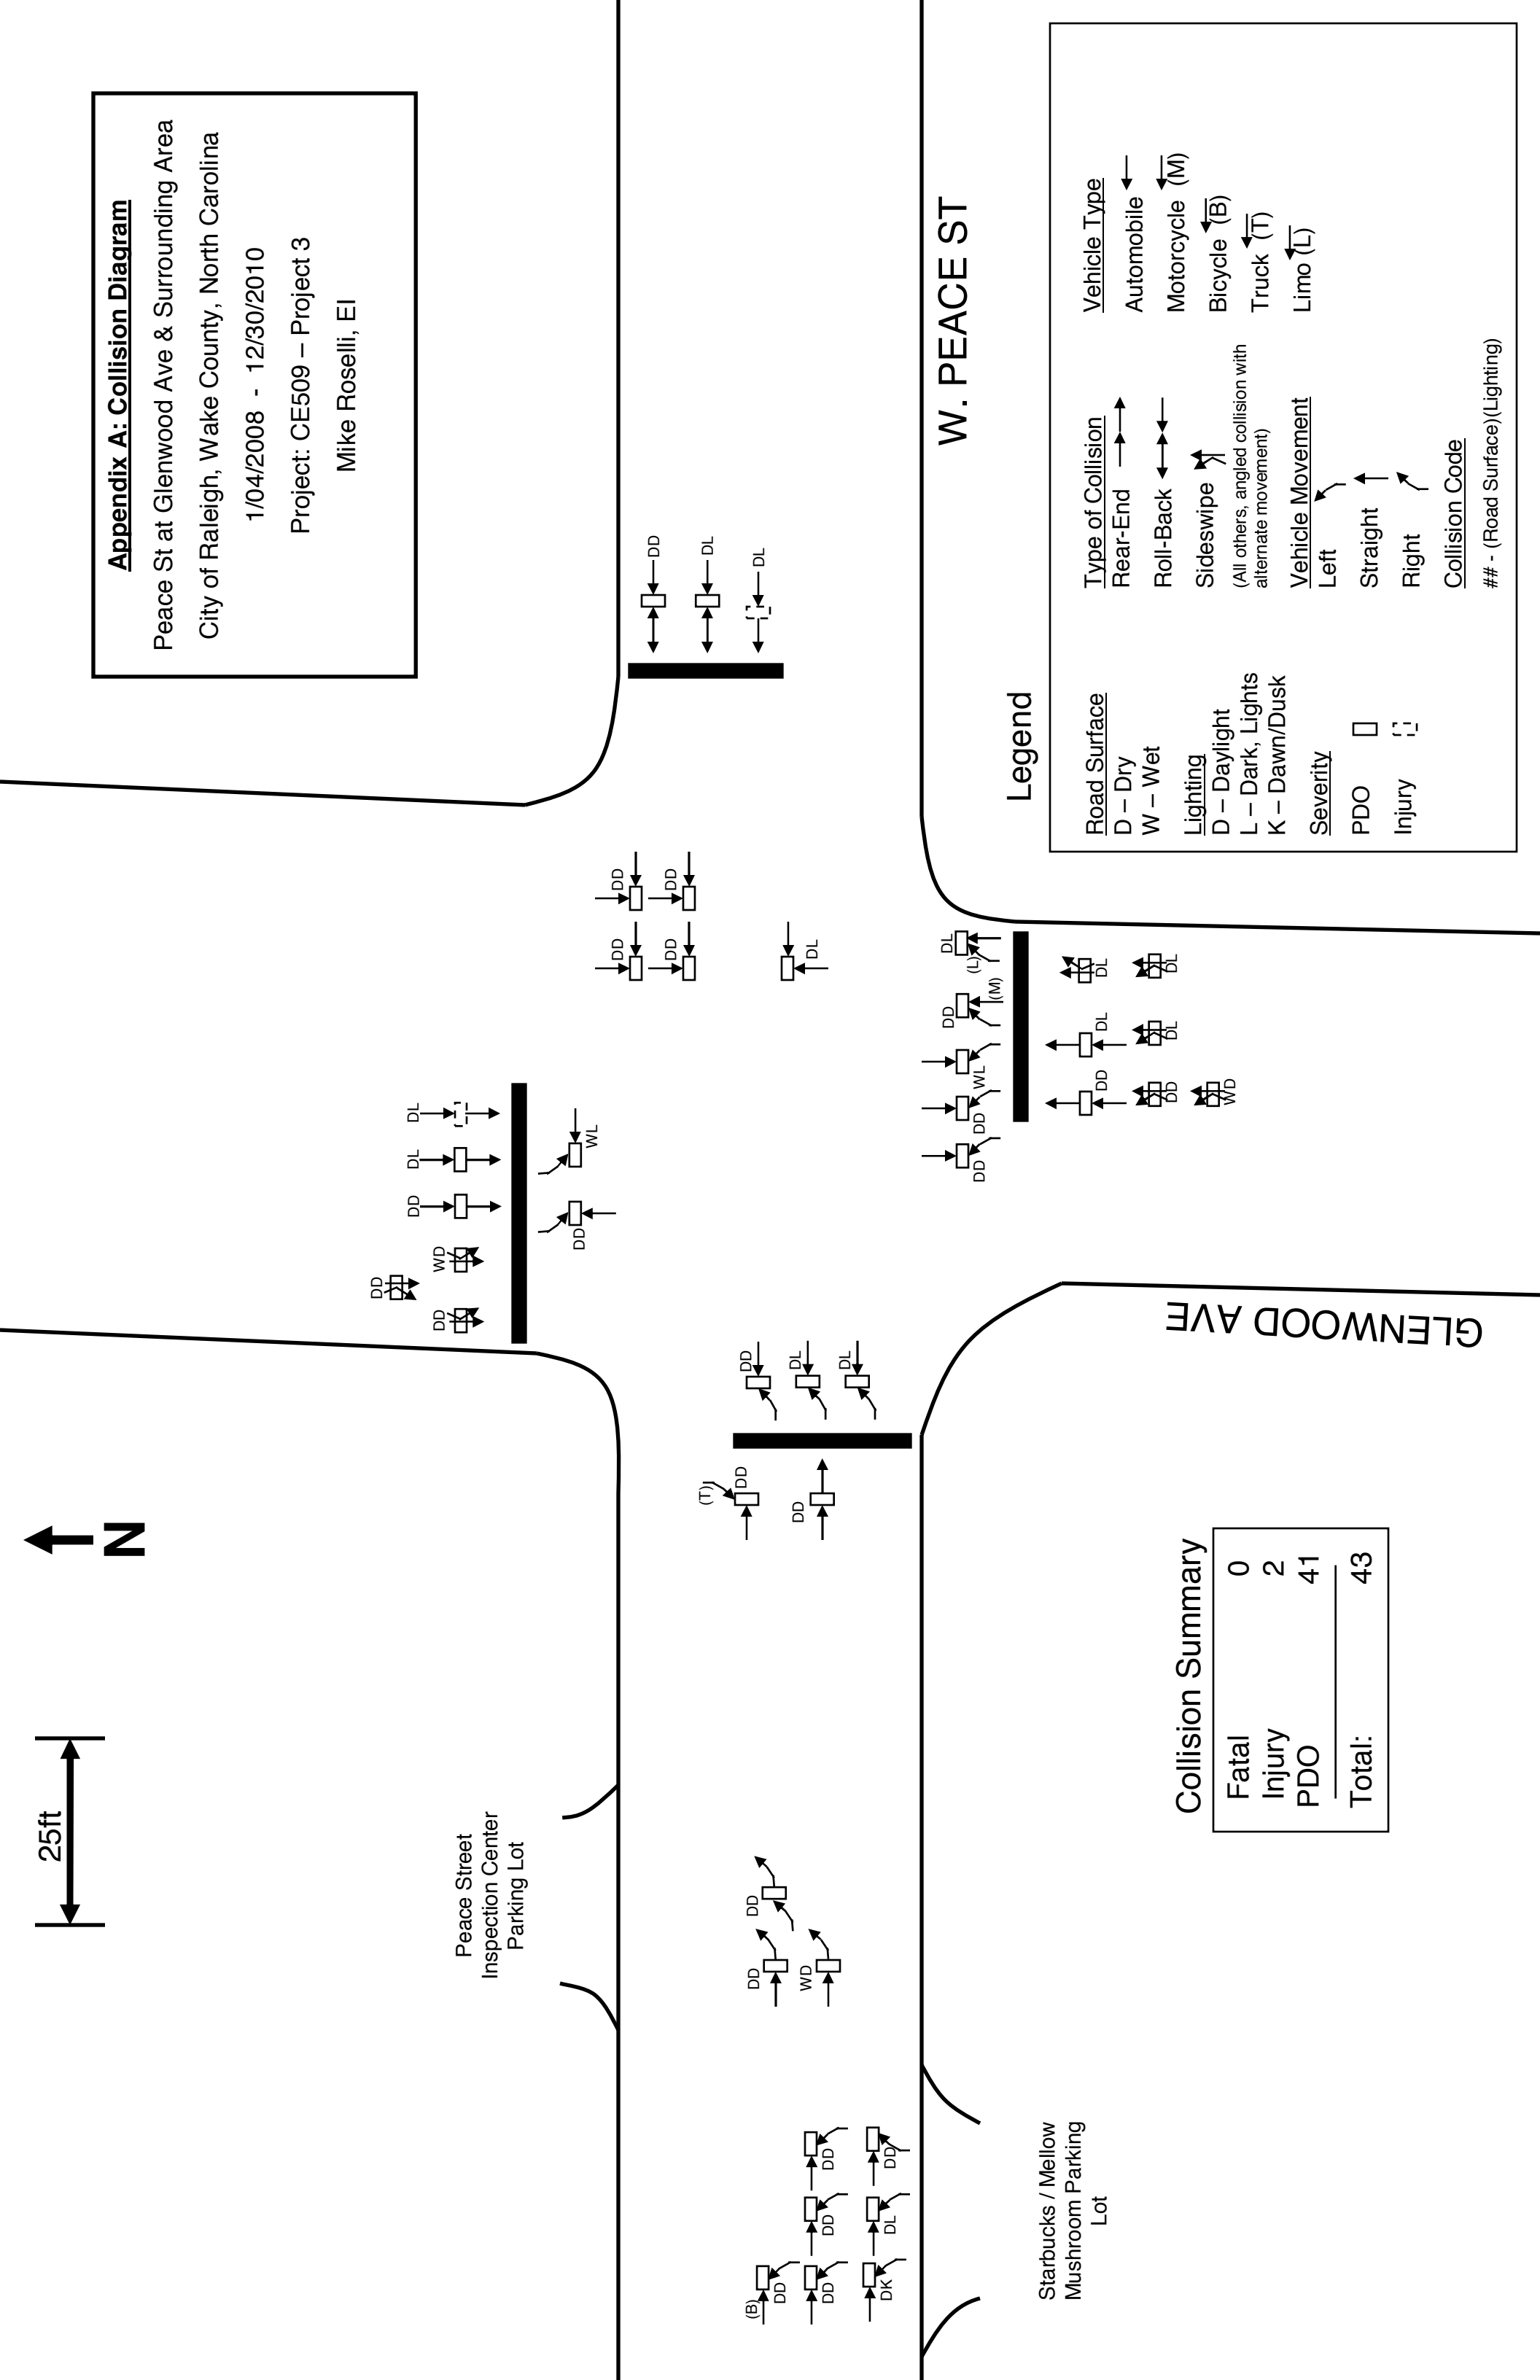
Appendix A: Collision Diagram

Collision data was requested for a three year period of reported collisions between the dates of January 4, 2008 and December 30, 2010. A collision diagram depicting this information can be seen in Appendix A. Intelligible reports and reports too far from the center of the intersection (outside scope of study) were removed, resulting in a diagram showing forty three collisions.

Patterns can be seen of driveway collisions and left turn collisions on eastbound Peace St, angle collisions on westbound Peace St, and illegal left turn collisions on northbound Glenwood Ave.

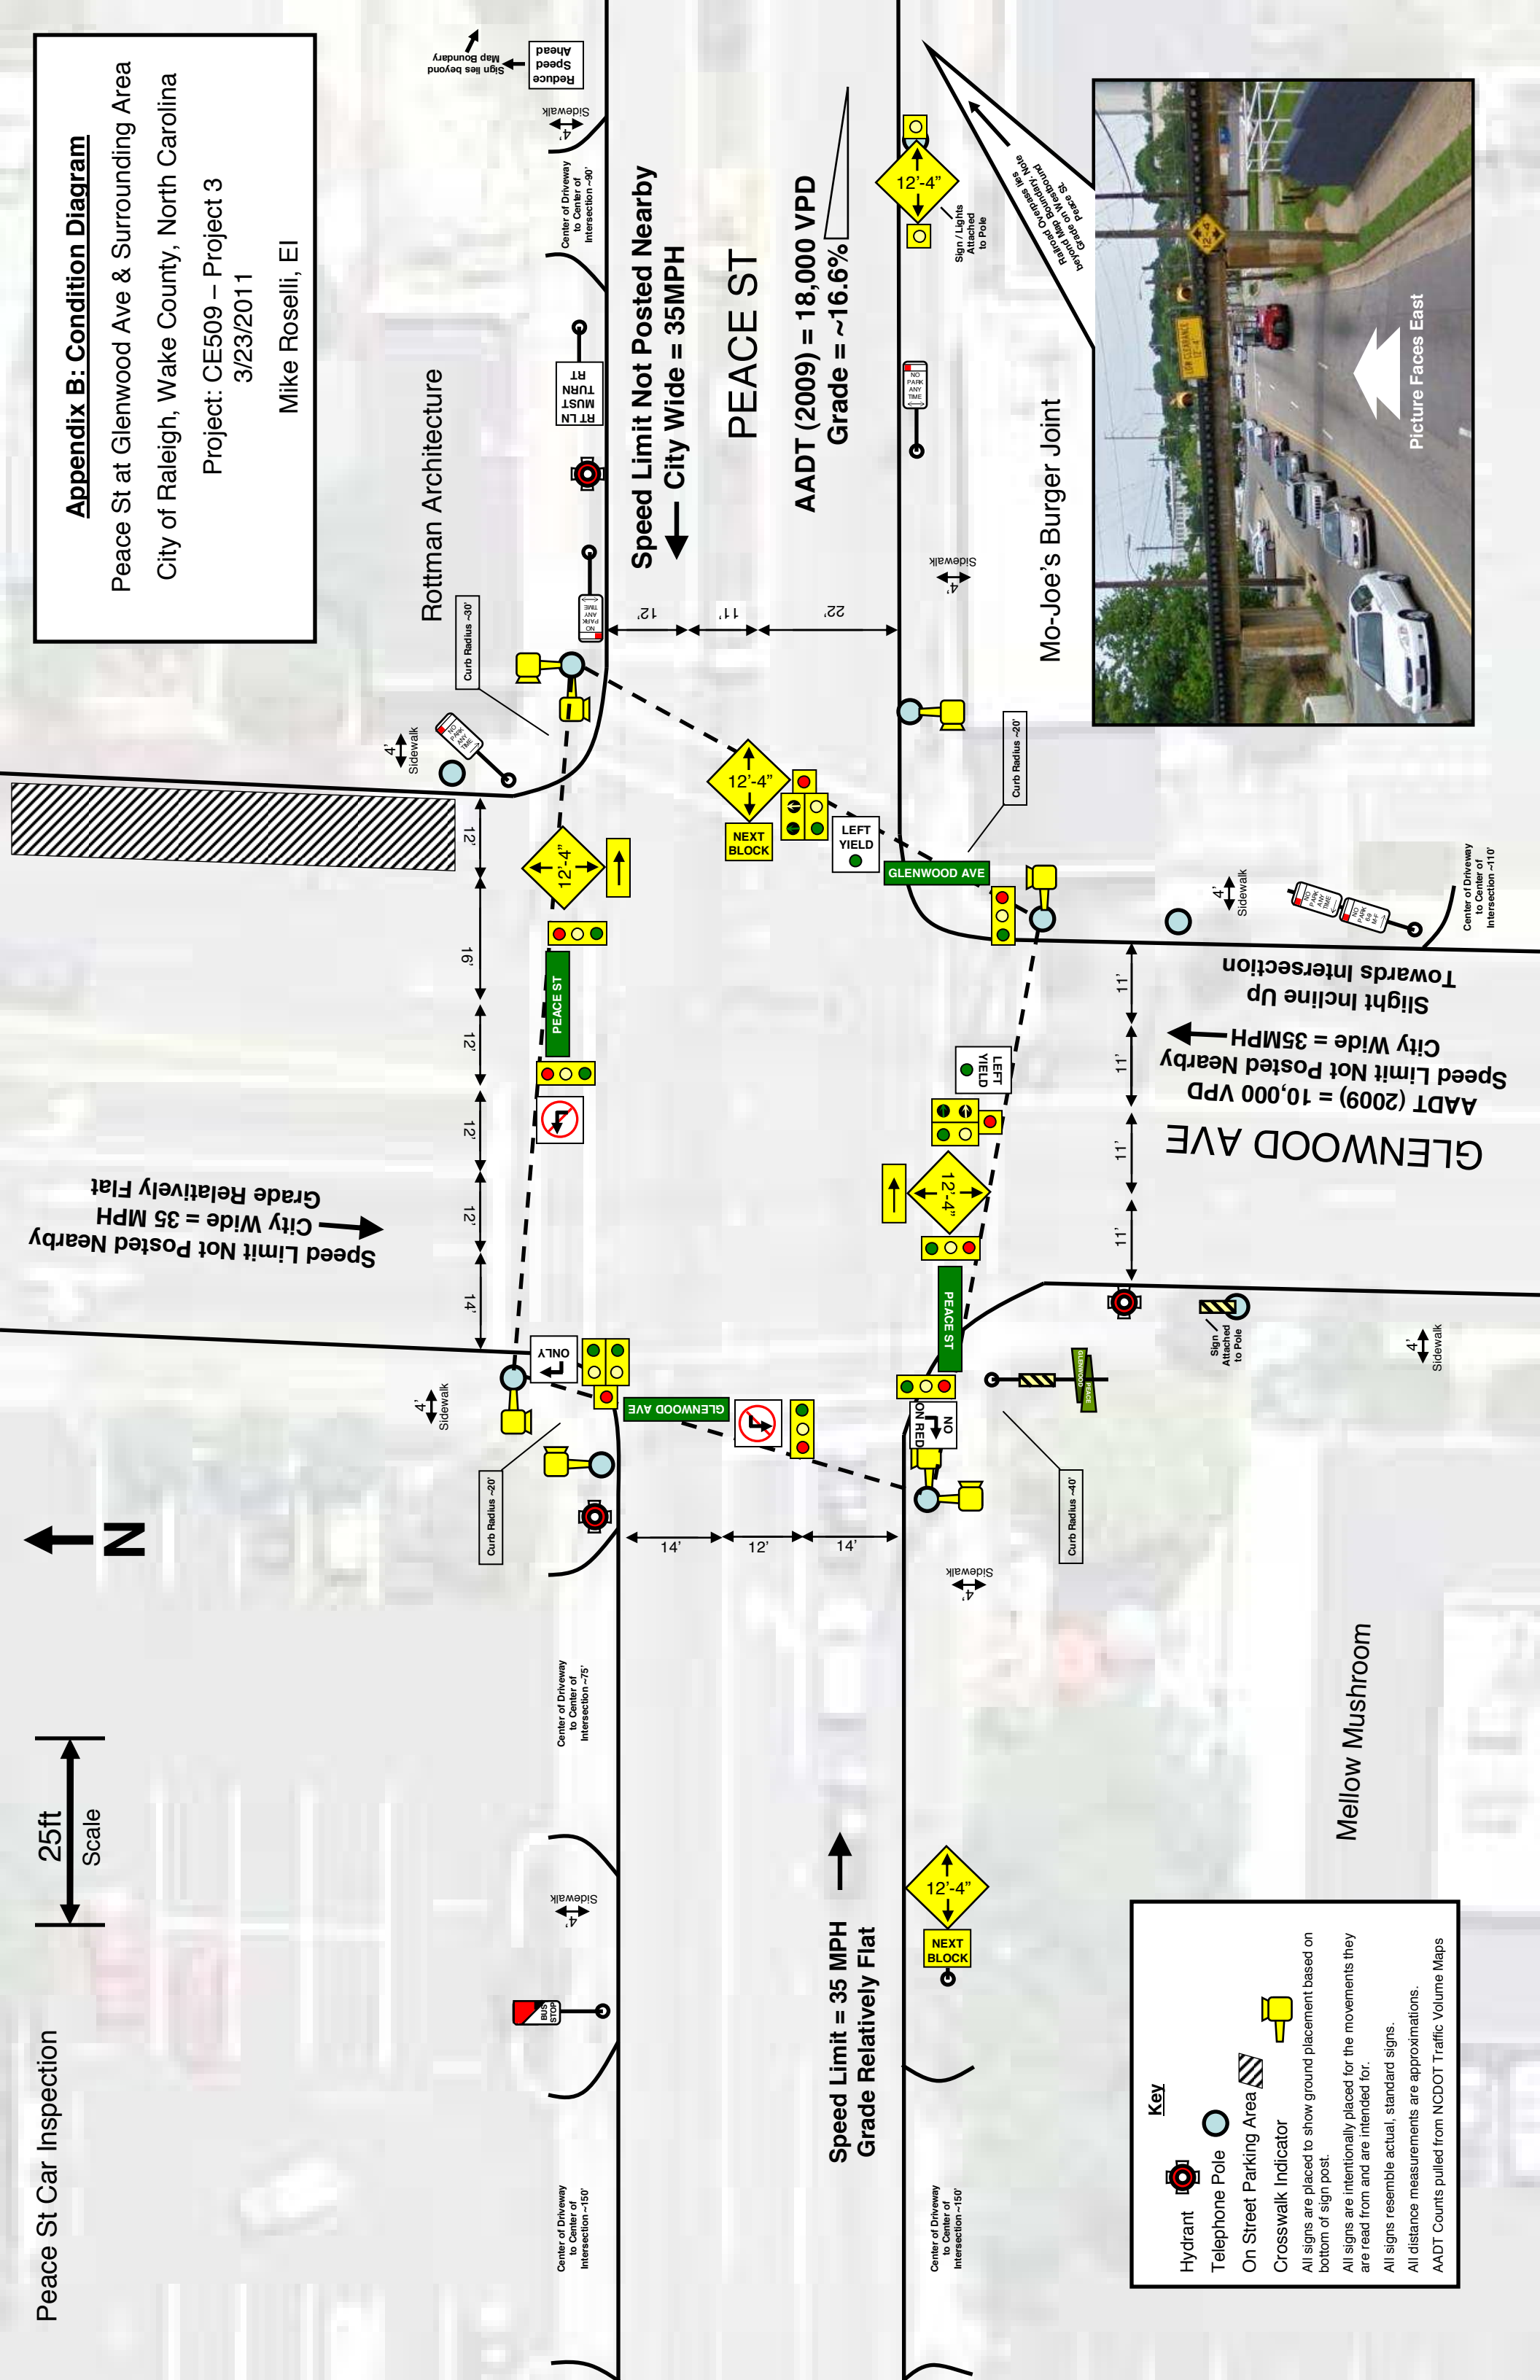
Appendix B: Condition Diagram

The two “No Left Turn” signs at both westbound Peace St and northbound Glenwood Ave are not obeyed; a few illegal left turns were noticed, but none that caused immediate danger. These could be caused by unfamiliarity, lack of signage, or blatant disobedience. Bottom line: the signs do not command the level of respect required.

Erratic movements and near-collisions were sighted by the driveways to the Mellow Mushroom restaurant and Starbucks Coffee on eastbound Peace St, an area with a noticeable collision pattern on the Collision Diagram. Eastbound vehicles turning north onto Glenwood Ave enter this lane very early, nearly as far back as the previous intersection, and proceed through the shared median lane at faster than the recommended 35mph in order to catch a protected left-arrow phase. This is probably because of lengthy eastbound queues combined with a long and uninterrupted median turn lane.
